# PLAY AREA SAFETY INSPECTION REPORT

For Bacton PC

On 7<sup>th</sup> August 2023

Play Area, St Marys Close, Bacton Suffolk

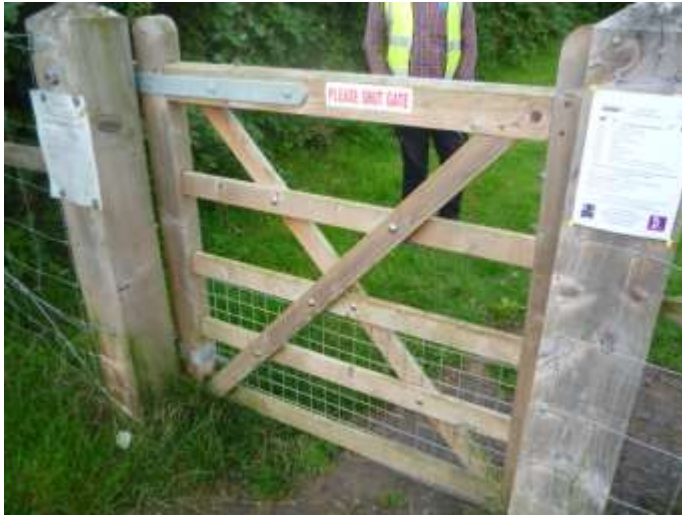
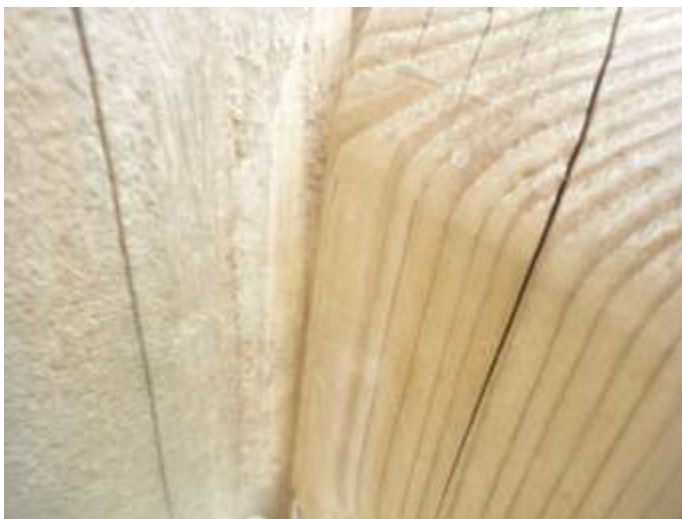
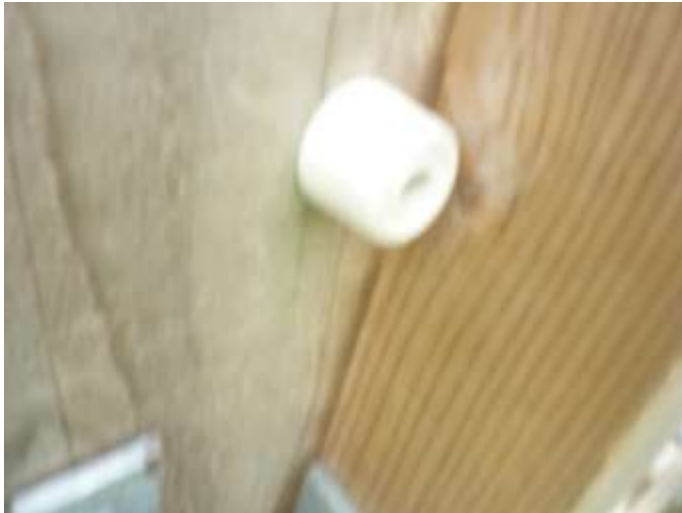
Timber Pedestrian Gate – Finger entrapment at gate - Recommend adjust rubber stopper so that achieve 12mm gap – Low risk.

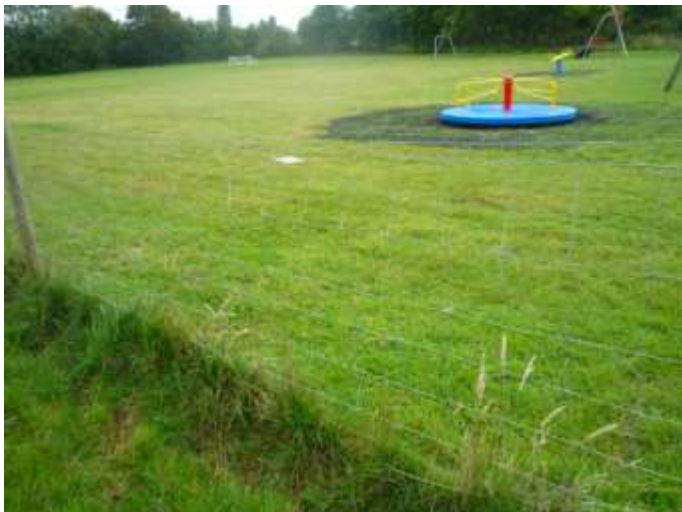
Wire Fence – Fence is climbable – Recommend to monitor - Low risk.

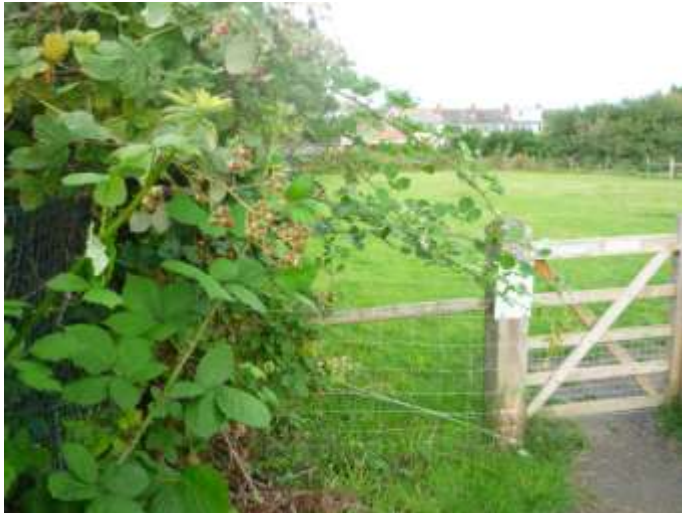
Planting – Recommend cut back brambles to fence line at main entrance  
- Low to Medium risk.

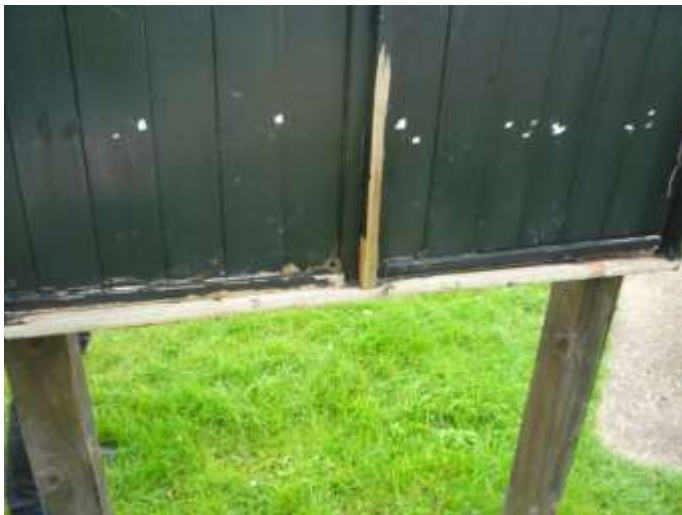
Timber Notice Board - Recommend repair loose sections - Low risk.

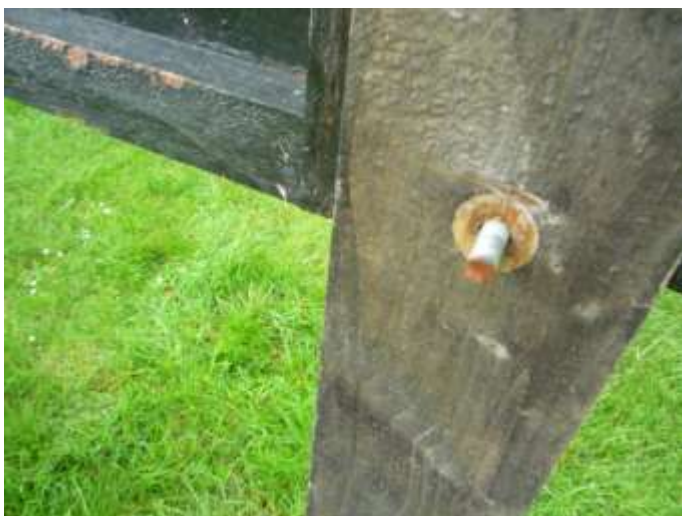
Recommend replace missing nuts - Low risk.

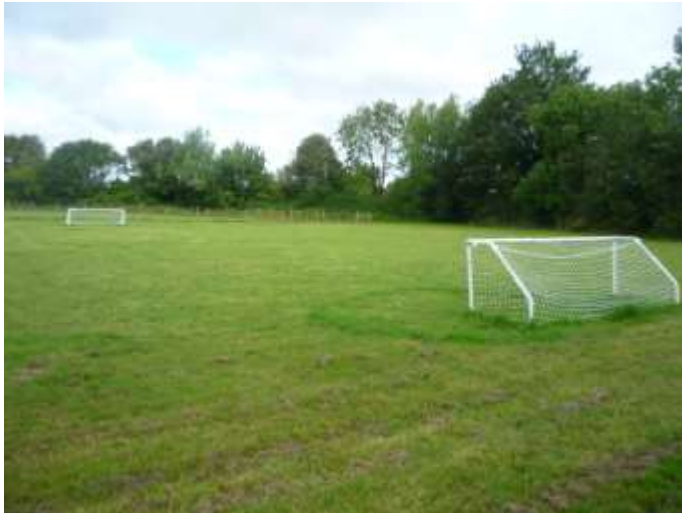
### **Item: Small Football Goals x 2 – Harrod Sports**

Recommend add more stakes to support at one goal - Low risk.

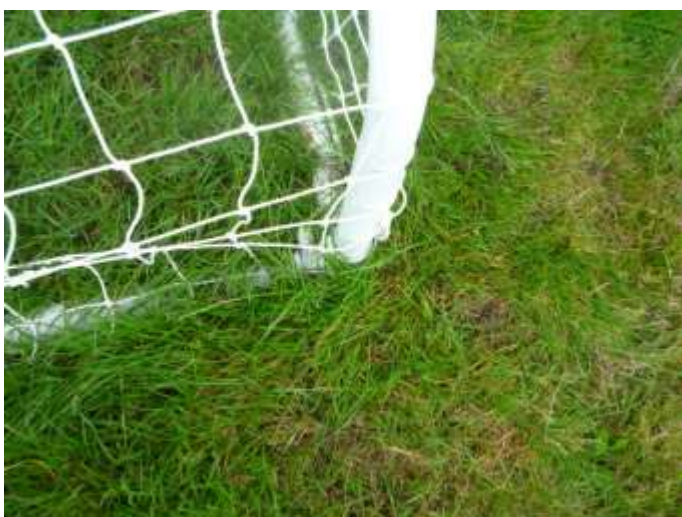
Recommend tighten one goals crossbar if possible – Low risk.

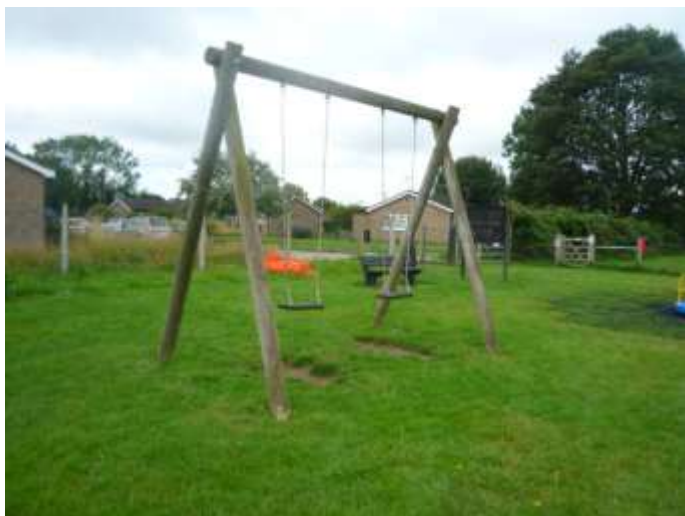
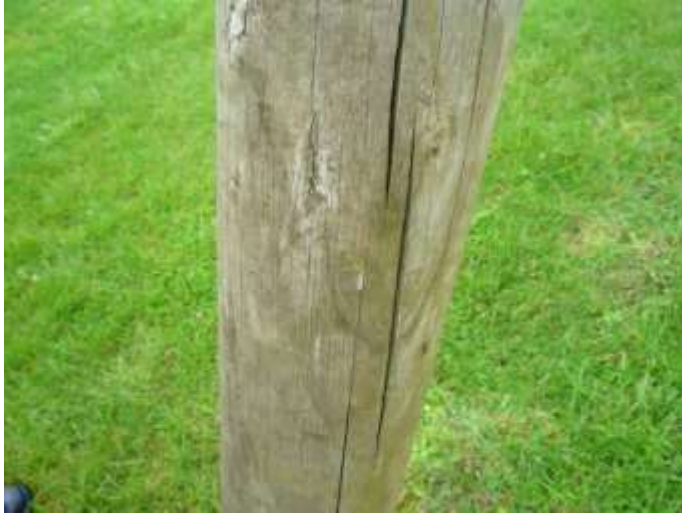
## **Item: 1 Bay 2 Flat Seat Swing (2700mm) – Adventure Playgrounds**

Recommend monitor cracks to timbers, smooth down any splinters when found, and ensure the cracks do not cross through fixing points of the structure and/or cause any instability. Replace any timber when 8mm and more gaps are found if in an area where a user grasps and climbs. (8mm and above fail the EN1176 finger entrapment probe when in an area that children grasp and climb.) Cracks let in water which may lead to rotting of timber (currently up to 5mm diameter cracks are found). Refer to manufacturers guarantee in regard to replacement criteria - Low risk.

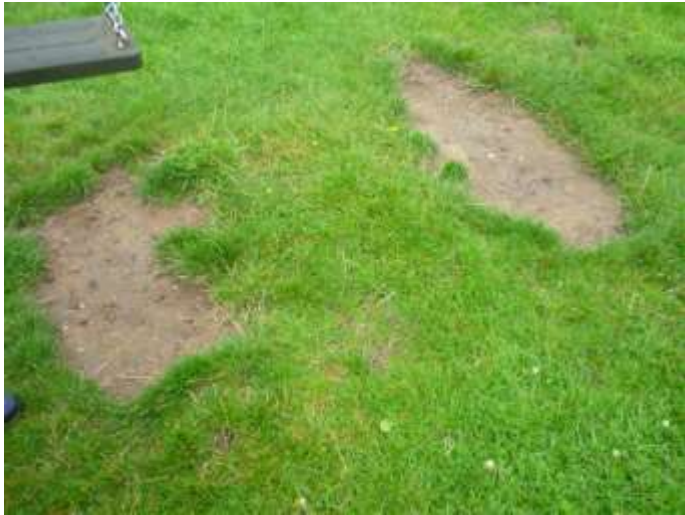
## **Surfacing: Safergrass Matting**

This type of safety surface should have grass present to provide adequate protection in user falls, as the grass roots absorb the impact of any falls. The surface therefore does not give the same protection as with grass and the risk of damage to users in falls is increased.

In the first instance it is recommended to raise the swing seat to 635mm (from safety surface to bottom of seat) and (when conditions allow) spread seed and soil mix over the worn areas - if this fails to eliminate wear from dragging feet serious consideration should be given to replacing this surface with a non-wearing type of safety surface such as Bonded Rubber Crumb or Wet Pour - Low risk.

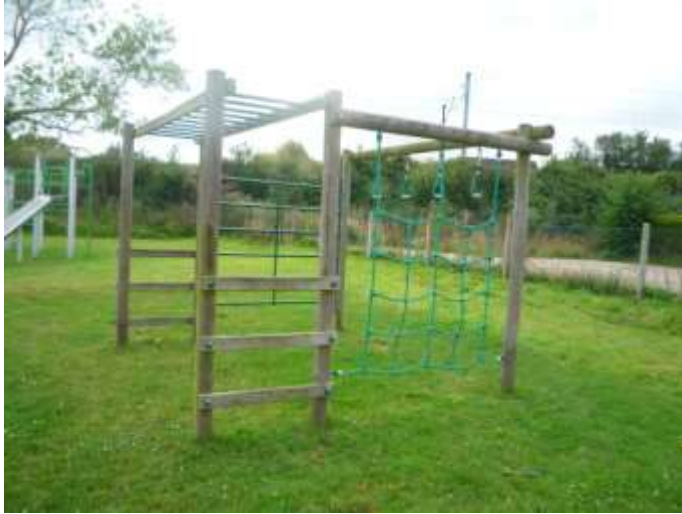
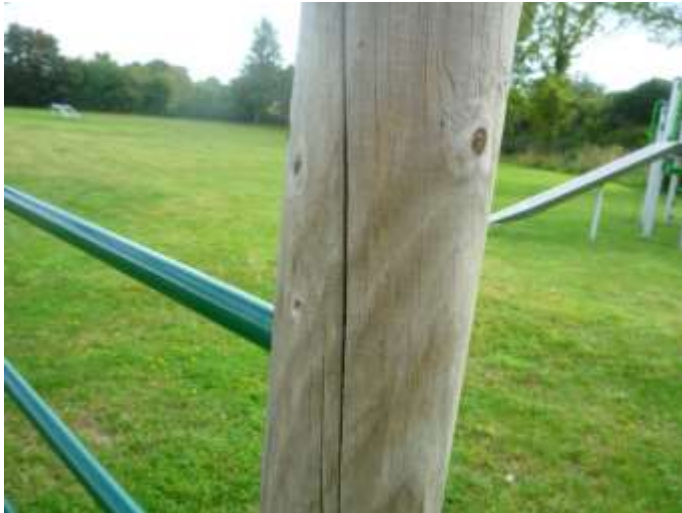
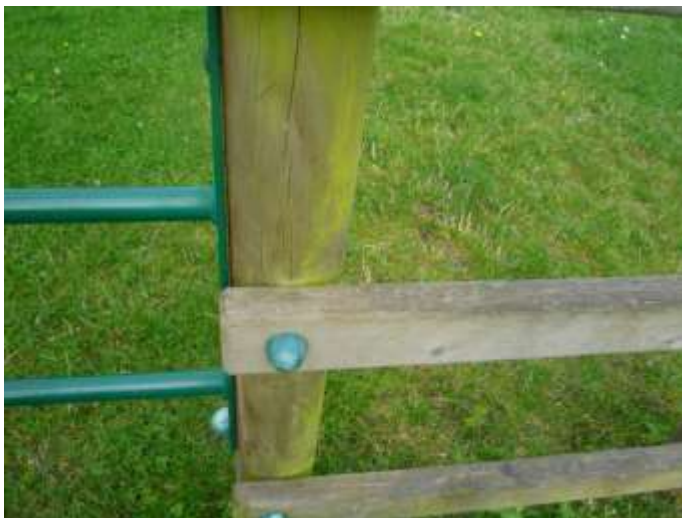
## **Item: Carlton 1 – Adventure Playgrounds**

Recommend monitor cracks to timbers, smooth down any splinters when found, and ensure the cracks do not cross through fixing points of the structure and/or cause any instability. Replace any timber when 8mm and more gaps are found if in an area where a user grasps and climbs. (8mm and above fail the EN1176 finger entrapment probe when in an area that children grasp and climb.) Cracks let in water which may lead to rotting of timber (currently up to 6mm diameter cracks are found). Refer to manufacturers guarantee in regard to replacement criteria - Low risk.

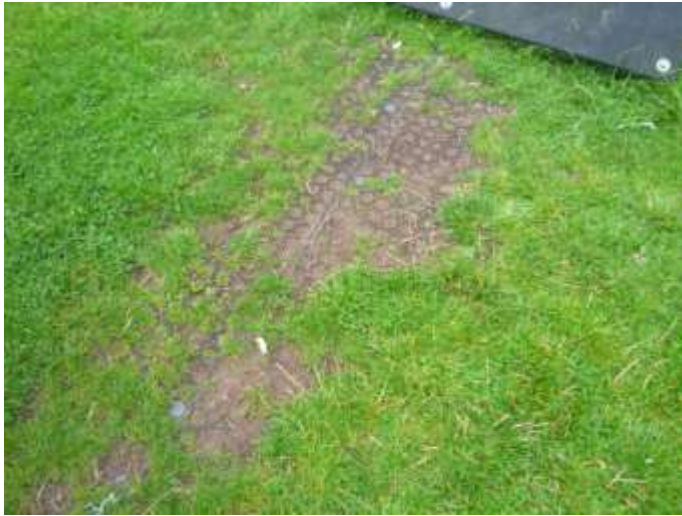
### **Surfacing: Safergrass Matting**

This type of safety surface should have grass present to provide adequate protection in user falls, as the grass roots absorb the impact of any falls. The surface therefore does not give the same protection as with grass and the risk of damage to users in falls is increased.

In the first instance it is recommended to spread seed and soil mix over the worn area – if this fails to eliminate wear serious consideration should be given to replacing this surface with a non-wearing type of

safety surface such as Bonded Rubber Crumb or Wet Pour – Low risk.

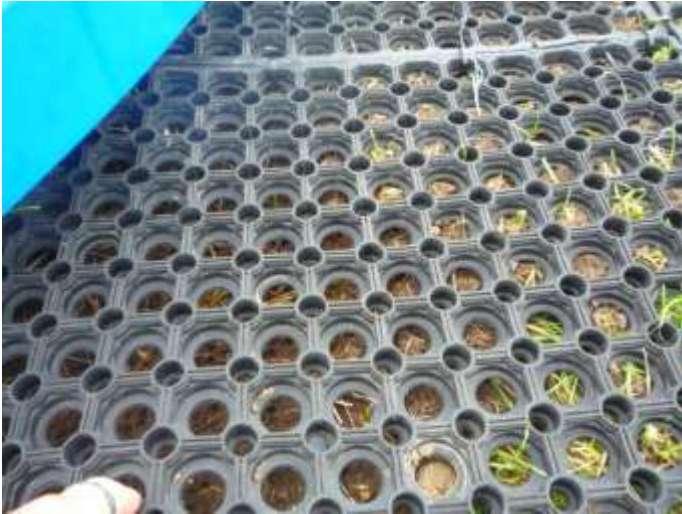
Recommend level up to eliminate trip hazards - Areas of heavy use may show signs of dipping and result in compaction of the soil. Decompact the ground by working a fork or a hand held aerator in the compacted areas. It may also be possible to lift the tiles about 50mm without breaking the seams whilst at the same time sieving a fresh top soil and

seed mix through the tiles. This will help to level any sunken areas - Low risk.
